INSPECTION REPORT

Self-propelled boom lift

Client:	Botany Access Pty. Ltd.		Test Date:	9 th June, 2020
Client Contact:	Paul Borg		Plant No:	KB3001
Location:	Newcastle Access, Kurri Kurri NSW		Purchase Order:	N15179
Subject:	Inspection of 20FT Genie boom lift KB3001 (S/N: Z30N09 - 11936)		ISA Job No:	20521
Inspected by:	Rory Hafey	Jordon Farlow	ISA Report No:	20521-1
			Revision:	0
Reported by:	Rory Hafey		Date of Issue:	19 th June, 2020

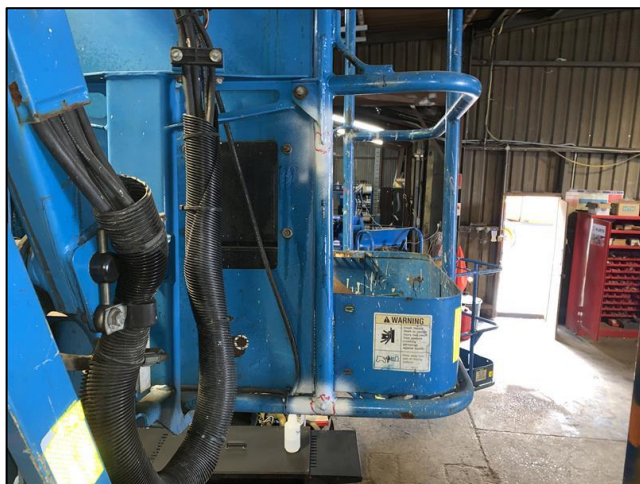
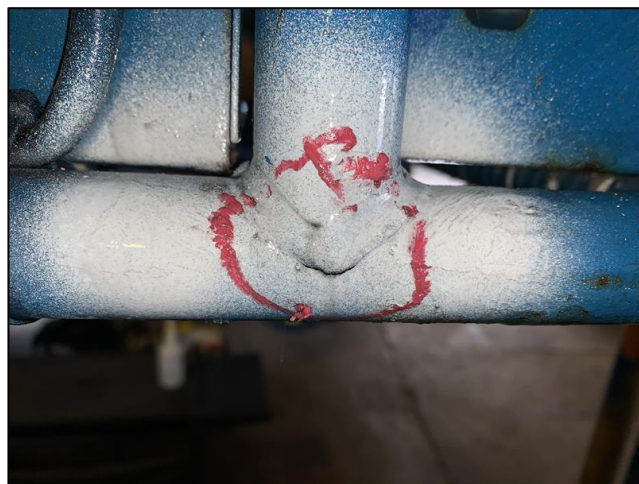
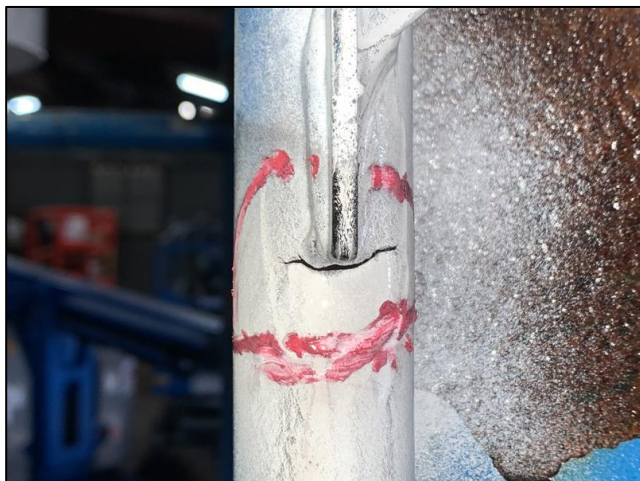
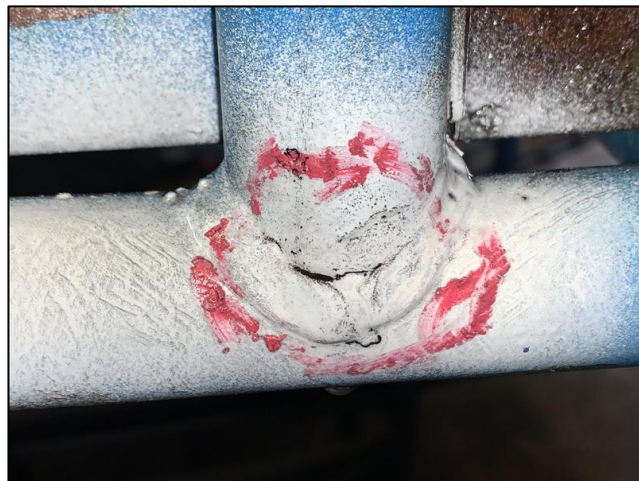
Boom to Jib Connection Knuckle	X			Nil cracking detected
	Pin Bosses	X			Nil cracking detected
	Cylinder Connection Clevises	X			Nil cracking detected
	Basket Knuckle Connections	X			Nil cracking detected
Basket / Knuckle	Pin Bosses	X			Nil cracking detected
	Basket Frame	X	X		6 areas of cracking, 10-40mm in length (see photos 5 to 10)
	Knuckle Connections	X			Nil cracking detected
	Basket Mounting Bracket	X			Nil cracking detected

Photos 5 to 8 – Overview cracking found on basket frame

Final Inspection – 19th June, 2020

After removal of all nominated cracking, and re-welding of new connections.

Nil further cracking was detected and new welding complies with AS1554.1.2014
